Boiler Tubes Failure: Causes and Remedies a Case Study of a Fertilizer Plant

Adarsh Kumar* and Pawan Kumar Sapra**

Case-I: Plant SGP (Mech), Section: Boiler-I Date: 15.09.2005

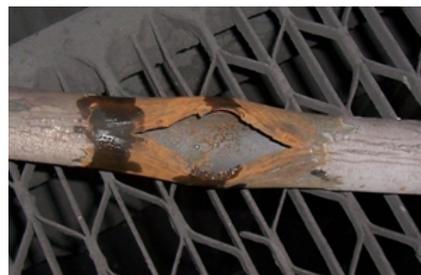
Observations of Import Steam Super Heater Tube Leakage

On 15.09.2005 coil no 1 from south side of ISSH reported leakage [5] on the bottom tube just above the economizer of this coil in segment-B. During analysis, it was found that failure occurred because of erosion caused by ash passing between this tube & skin casing. Around one meter length of the tube had severe thinning because of this erosion. Also the tube just above this tube in the same coil had severe thinning. Then the coil was plugged with alloy steel taper plugs on both the headers using E-8018 electrodes.

Superheater Fireside Ash Corrosion resulted in external tube wall loss and increasing tube strain. Tubes commonly have a pock-marked appearance when scale and corrosion products are removed. Fireside ash corrosion is a function of the ash characteristics of the fuel and boiler design. It usually is associated with coal firing, but also can occur for certain types of oil firing. Ash characteristics are considered in the boiler design when establishing the size, geometry and materials used in the boiler. Combustion gas and metal temperatures in the convection passes are important considerations. Damage occurs when certain coal ash constituents remain in a molten state on the superheater tube surfaces. This molten ash can be highly corrosive

Fig. 1. Import Steam Super Heater Tubes of Boiler-I SGP NFL Naya Nangal.

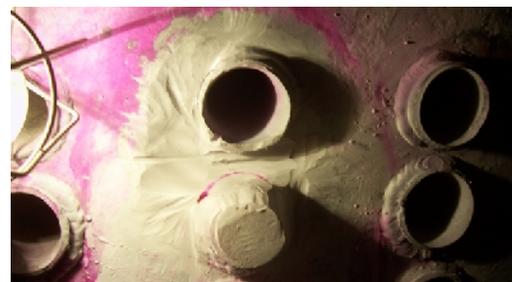
Failure Observation of Bank tubes leakages

Leakage was observed in boiler no 2 in bank tube south side and steam leakage was observed in the north side near ISSH. Manhole cover of ISSH and economizer were opened and observations are 8th row (W-E) and tube No 4(N-S) in the north cluster were completely open [5]. Skin casing was cut and removed and observed that leakage was at the outlet of the steam drum. This leakage had also damaged the 7th tube in the same cluster due to impingement of water. After scanning the tube it was decided to plug the tubes ends.

Cause. Failure of the first tube was contributed to the leakage travel between tube outer diameter and tube sheet internal diameter. The small pinhole in the weld joint is responsible for the leakage of the other tubes. The photographs of the damaged tube are given below. Stress corrosion cracking failures were observed as in a thick wall, brittle-type crack at location of higher external stresses, such as near joints was observed. These failures are associated with austenitic super heater materials and can lead to either transgranular or intergranular crack propagation in the tube wall. It occurs where a combination of high-tensile stresses and a corrosive fluid are present. The damage results from cracks that propagate from the ID. The source of corrosive fluid may be carryover into the superheater from the steam drum or from contamination during boiler acid cleaning if the superheater is not properly protected

Fig. 4. Plugging of Bank Tubes of Boiler-II SGP NFL Naya Nangal.

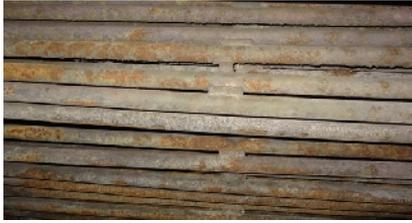
Failure Observation of Bank tubes leakages

Bank tube leakage in boiler -2 was observed as water was coming out from the tubes, plant was shut down and investigation was done. After cutting skin casing of the taper portion the observation were made are: water was coming from the root of the 4th tube in 6th row from west side in the north cluster [5]. Cracks in the tube were observed which are irreparable and this tube as plugged from the ends. DPT after grinding was done of nearby tubes for any leakage and found satisfactory.

Cause. Tube damage was occurred due to the combination of thermal fatigue and corrosion. Corrosion fatigue was influenced by water chemistry and boiler water oxygen content in the boiler water during operation. The Combined effect leads to the breakdown of the protective magnetite on the ID surface of the boiler tube. The loss of this protective scale exposes tube to corrosion.

Fig. 5. Bank Tubes of Boiler-II SGP NFL Naya Nangal.
